**FOREIGN OBJECT DAMAGE:
CAUSES AND PREVENTION**

1 January 1970 through 31 December 1976

by
MSG Jerry E. Mills

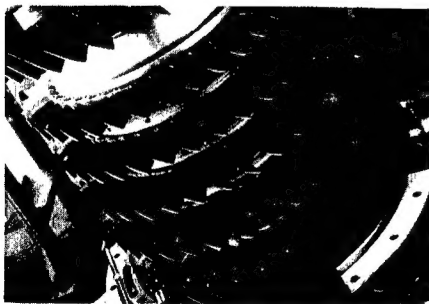
- UH-1C forced landing - Engine failed during flight. Caused by ingestion of Dzus fastener into compressor section. (figure 1)

FIGURE 1.—Damage to compressor blades caused by ingestion of Dzus fastener.

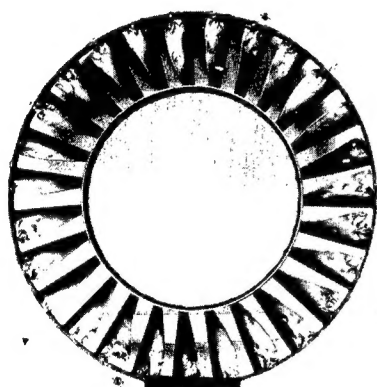
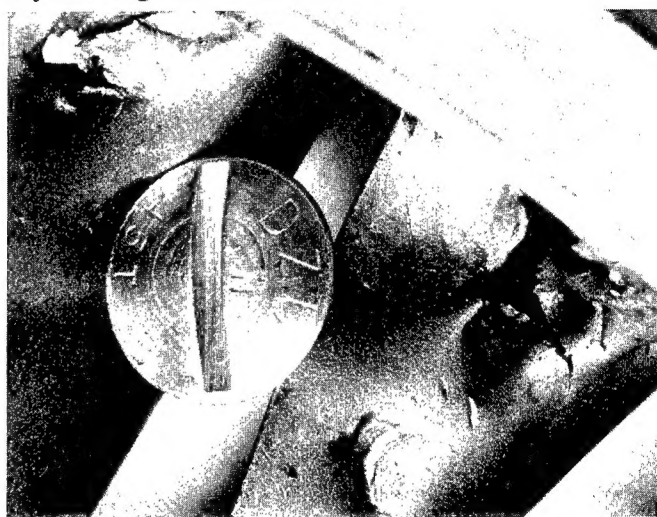
- UH-1H incident, \$438 damage - Aircraft was in stabilized hover during test flight when several loud bangs were heard and heavy feedback in controls and severe vibrations were felt. Hovering autorotation was executed, resulting in hard landing. Investigation revealed severe FOD. Imprints of the phillips head screw and threads and general imprint of Dzus fasteners left little doubt as to the type of foreign objects. (figures 2a and 2b)

FIGURE 2a.—Damage to inlet guide vanes caused by Dzus fastener.

FIGURE 2b.—Closeup of damage.

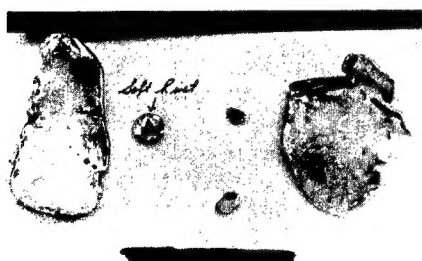
FIGURE 3.—Compressor blades and rivet removed from engine.

- AH-1G total loss, 2 injuries and \$471,630 damage - During final approach, high sink rate was encountered. There was no response to applied corrective action. Aircraft impacted twice and then became inverted in water. Investigation revealed engine malfunctioned due to FOD. The object could not be definitely identified, but it resembled a soft rivet. (figure 3)

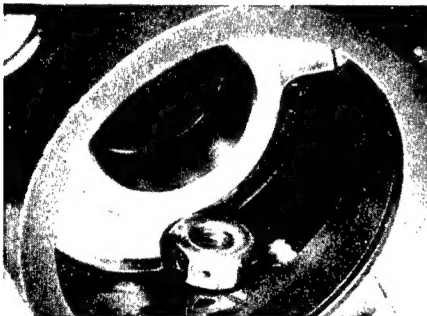
FIGURE 5.—Nut found in oil inlet cavity.

- UH-1H precautionary landing - Master caution light came on and engine oil pressure dropped to zero. Nut was lodged in oil inlet cavity. (figure 5)

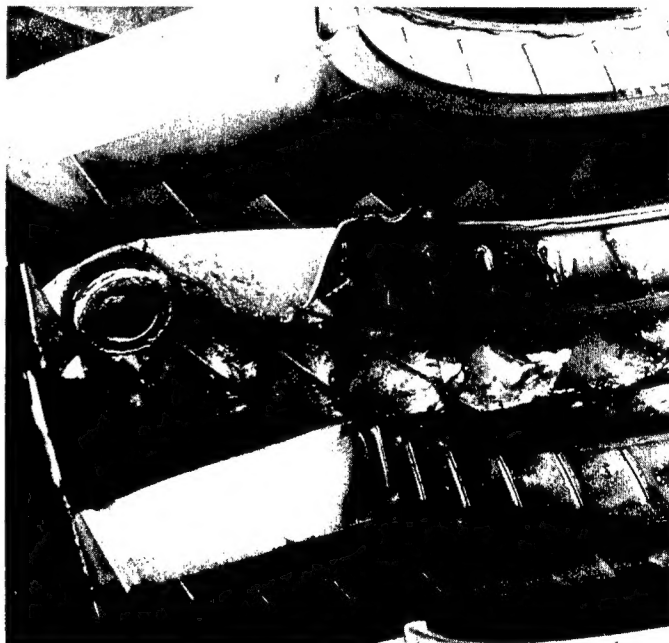
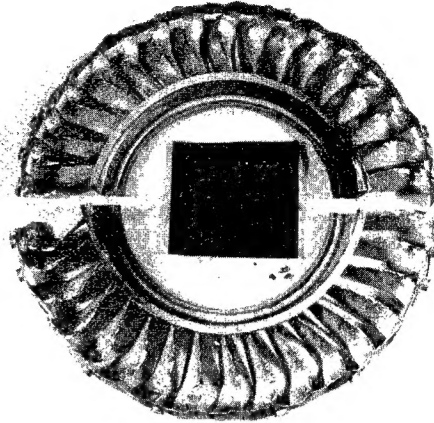
FIGURE 6a.—Washer ingested in stator vanes . . .

- CH-47A precautionary landing - Loud bang was heard and vibrations felt. Failed engine was secured and landing was made. Teardown analysis revealed a washer, used for drive shaft installation, was ingested. (figures 6a and 6b)

FIGURE 6b.— . . . caused damage to vane assembly.

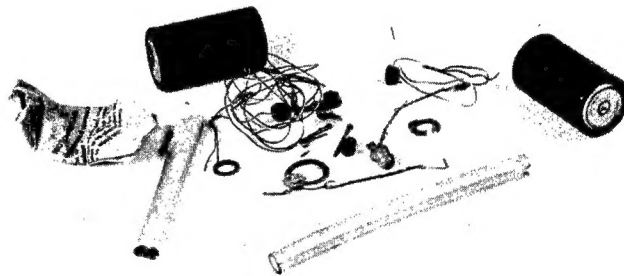
FIGURE 7.—During a safety survey of an airfield, these objects were policed up from the ramp and helipads where aircraft were in operation.

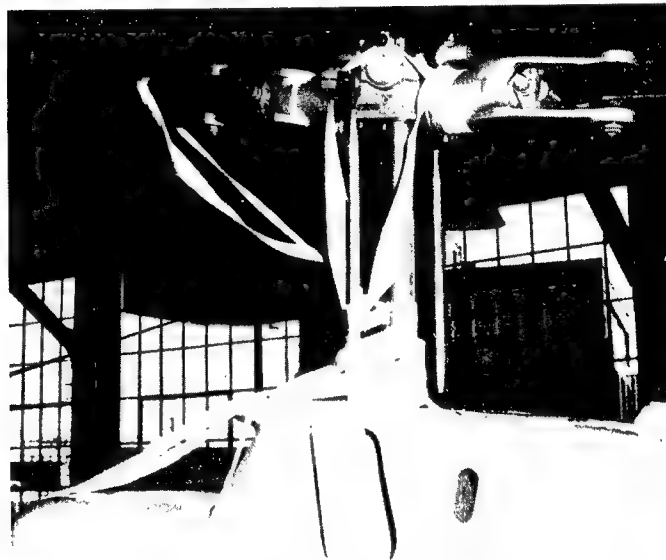
- OH-58A incident, \$182 damage - While OH-58 was at flight idle, another aircraft hovered onto adjacent pad for landing and blew 100-foot section of engineer tape into rotor system. Tape was in mast and around pitch change tubes. (figure 8)

FIGURE 8.—Hovering aircraft blew engineer tape into OH-58 rotor.

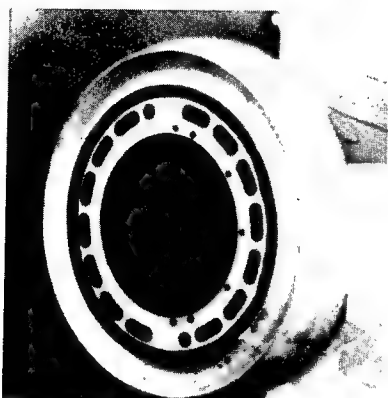
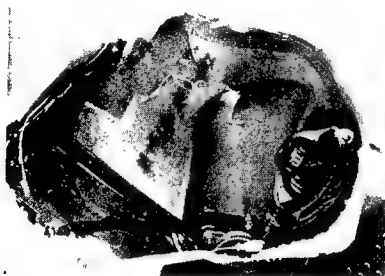
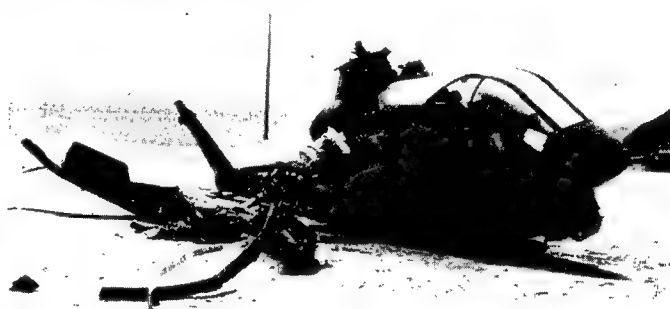
FIGURE 9c

- AH-1G, OH-6A major accidents, \$210,552 damage - During flight unsecured items blew out of ammo bay and passenger areas, hitting tail and causing tail rotor failure. (figures 9a, 9b, and 9c)

FIGURE 9a
Deflector assembly . . .

FIGURE 9b
caused tail rotor system to depart aircraft... and caused this.

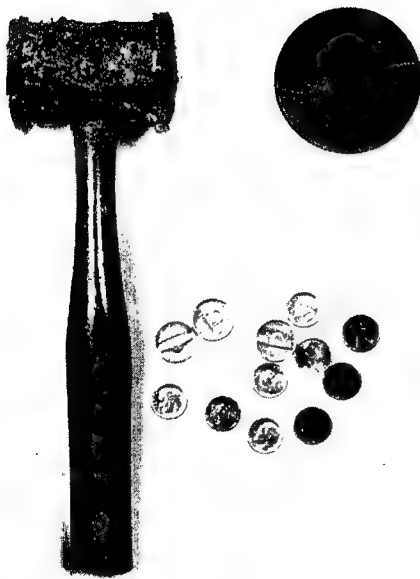
Some time ago, aircraft were brought to a maintenance facility to replace the existing fuel system with the crashworthy fuel system. As part of the routine induction, fuel samples were taken from each aircraft. Laboratory tests revealed particles of unknown substance. Since the fuel system modification was to be accomplished, the contaminated fuel was not a great concern. Defueling and purging of lines were routine. Since no contaminants were found in the lines, further investigation for the contaminant was in order. Inspection of the removed noncrashworthy fuel cells revealed numerous foreign objects. Figure 10 shows what was found in three separate fuel cells. It appears the rawhide mallet was left in the cell at initial installation. The 69 cents in change and the fuel nozzle cap (with the retainer cable) remain a mystery as to how they could have found their way into the cells. The money could have been lost upon installation or repair of the fuel cells and the nozzle cap during a refueling process. Numerous other items such as rivets, fuel nozzle strainer, etc., were also found.

FIGURE 10.—Foreign objects found in fuel cells during modification process.

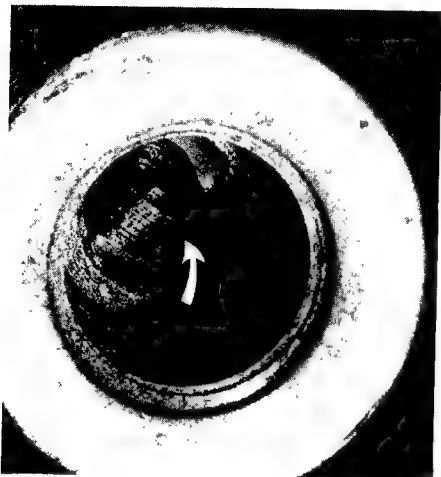
Figure 11 shows a metal shaving which was found in the inlet port of a fuel control, restricting fuel flow.

FIGURE 11.—Metal shaving found in inlet port of fuel control.

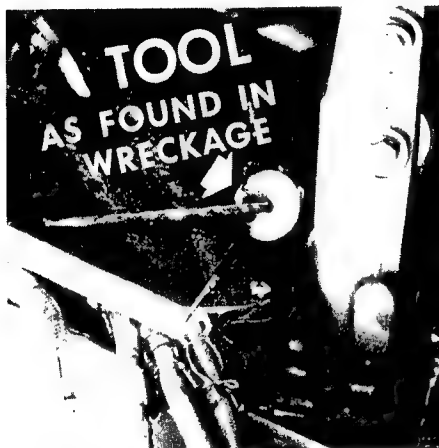
There were cases where tools were found at accident sites but they were not considered causes or contributing causes of the accident. One such case was an AH-1G major accident. A pair of side-cutting pliers was found in the fuselage. The pliers were very rusty and unusable, and did not display any fresh markings. Other tools found in the wreckage included a screwdriver (figure 12) and a 7/16 open-end wrench (figure 13)

FIGURE 12.—Screwdriver found in wreckage of AH-1G.

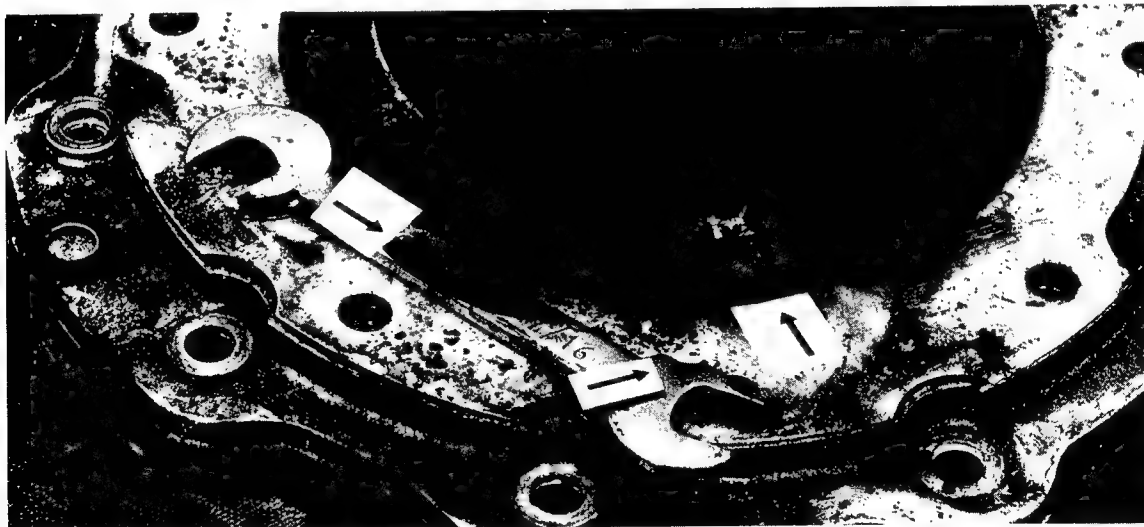
FIGURE 13.—Open-end wrench found in wreckage of AH-1G.

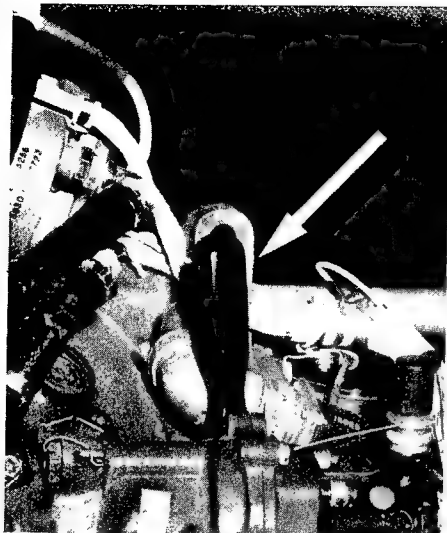
FIGURE 14.—Eighteen-inch screwdriver found on UH-1 engine.

Figure 14 depicts an 18-inch screwdriver found on a UH-1 engine. At least five different pilots had flown this aircraft and it had gone through two intermediate inspections before the screwdriver was found during the third inspection.

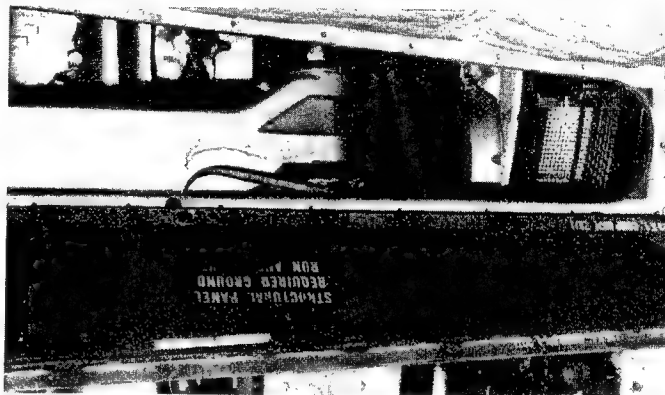
Figures 15 and 16 show damage to a UH-1H main transmission support case. A crew chief noticed something wedged between the transmission and side structural panel. Removal of the panel revealed the damage. It is suspected the cotter key removal extractor was dropped in the transmission well while work was being performed in the area of the main rotor hub assembly 25 to 30 hours before discovery. Damage resulted in replacement of the main transmission.

FIGURE 15.—Cotter key extractor found in transmission support case.

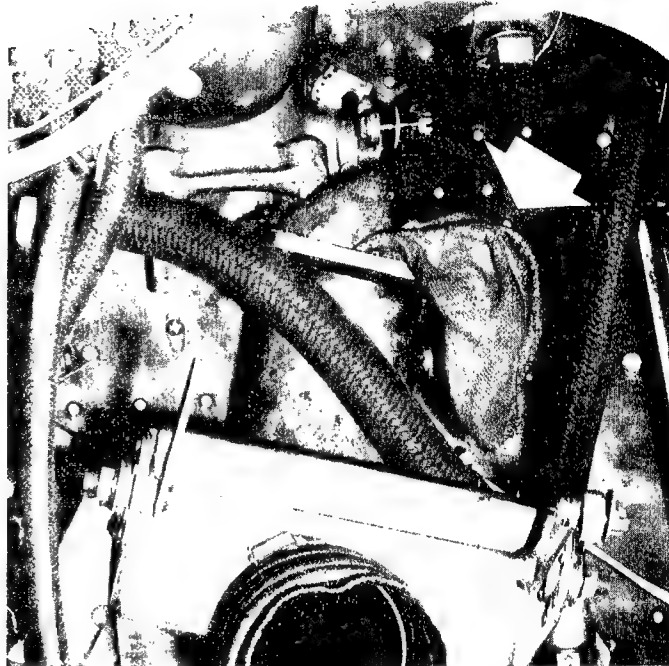
FIGURE 17.—Rag lodged in carburetor induction elbow assembly.

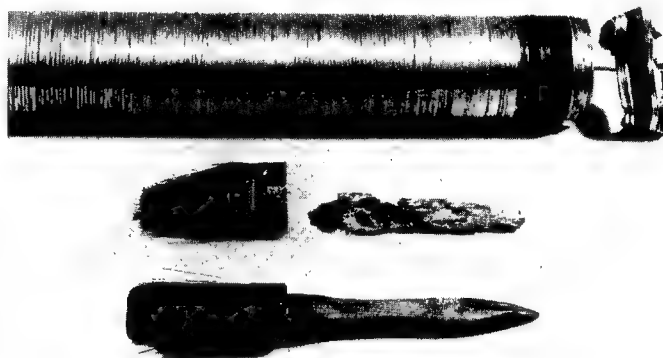
- UH-1H minor accident, \$4,366 damage - Landing approach was made and terminated at hover. During hover, sound was heard and directional control was lost. After one complete clockwise rotation, aircraft touched down. The third section of the tail rotor drive shaft had failed due to FOD caused by paint brush. (figure 20)

FIGURE 20.—Sheared tail rotor drive shaft caused by paint brush. New brush is shown with brush that caused damage.

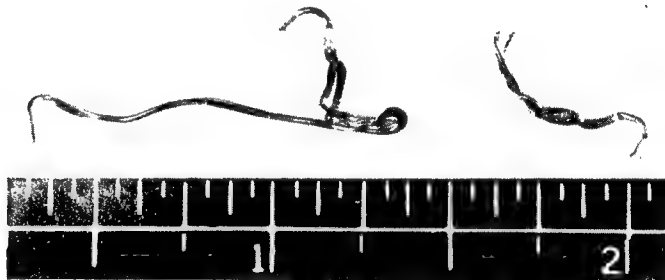
Figure 23 shows safety wire residue found in the gearbox assembly of a T63A700 engine. The engine was undergoing analysis for a different reason, but the fact remains that the wire could have caused an emergency.

FIGURE 23.—Safety wire found in engine gearbox assembly.

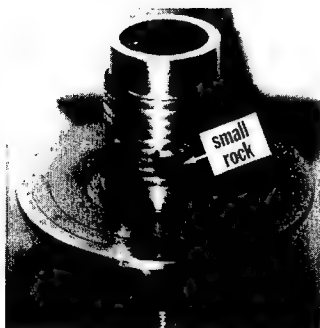
Figure 25 shows what a small object can do. As a fuel sample was being taken from the forward fuel cell of an AH-1G, the sump drain valve stuck in the open position. The fire department was immediately notified, the battery was disconnected, and the aircraft was grounded. A POL truck was used for defueling. Had the aircraft been moved with ground handling

FIGURE 25.—Rock in fuel sump drain valve allowed it to be stuck in open position.

wheels and a tug, a skid could have dragged on the concrete, creating a spark and igniting the 262 gallons of JP4 pouring on the ramp. What caused all this? A small rock was found lodged in the spring mechanism of the push drain valve.

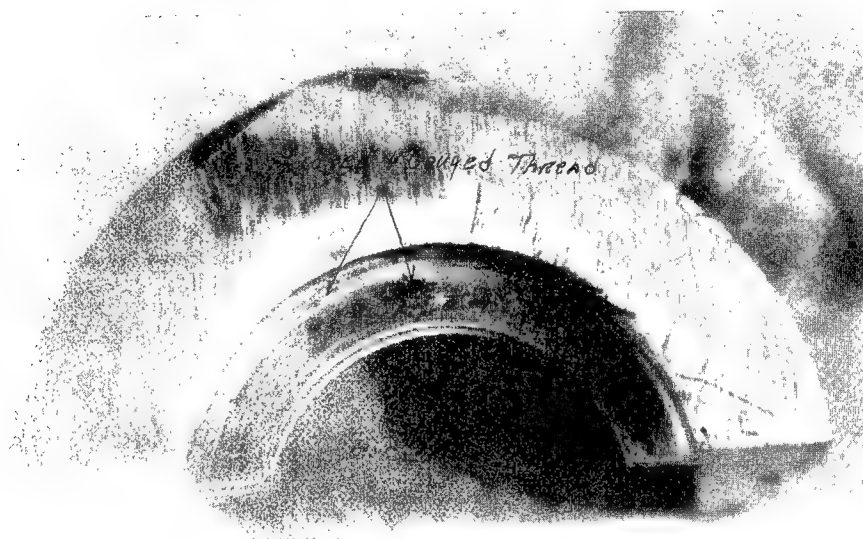
Particles of sand and other foreign matter can cause extra work due to inspections and time required for retaking oil samples. Figure 26 shows an enlarged internal thread area of a UH-1 tail rotor control quill. The threads were scored and gouged from the sand and other foreign particles during movement of the control quill. Particles of the soiled film lubricant and the base metal can work into the tail rotor gearbox. These minute particles, together with excess grease from the crosshead assembly, can damage the 90-degree gearbox.

FIGURE 26.—Scored threads of UH-1 tail rotor control quill. Damage caused by sand and other foreign particles.

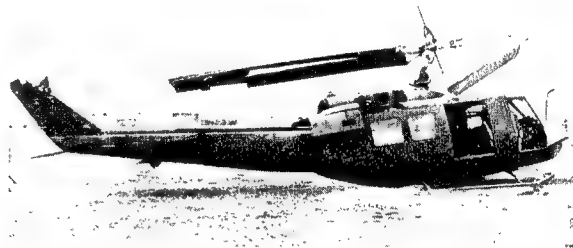
- UH-1H major accident, \$73,000 damage - Aircraft was in level flight when loud bang was heard and tail rotor loss occurred. Aircraft hit hard and blades struck ground. Engine inlet cover had been left on roof of aircraft during preflight. Cover struck red tail rotor blade, and tail rotor, 90-degree gearbox, and a portion of the drive shafting separated from aircraft. (figures 27a, 27b, and 27c)

FIGURE 27a.—Unsecured engine inlet cover . . .

FIGURE 27b.—
. . . struck tail rotor . . .

FIGURE 27c.—
. . . and caused this.

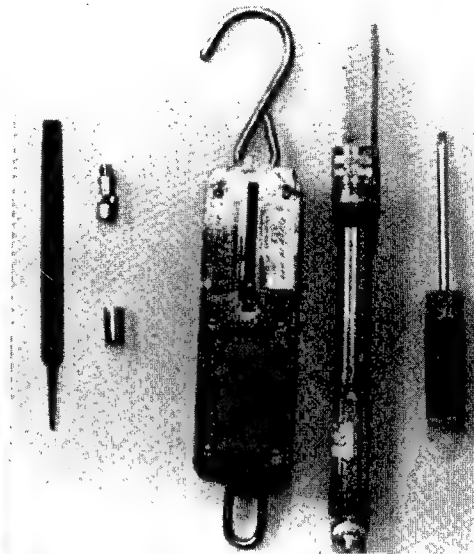
FIGURE 29.—This 1/4-inch wrench was found during a proper daily inspection. Aircraft had been out of PE 3 weeks and had 5 hours' flight time.
